Manhole Inspection Summary

Manhole # S07AA2015MH

Location Address: **2700 CROSS COUNTRY BLVD** Cross Street: **GLEN AVE**

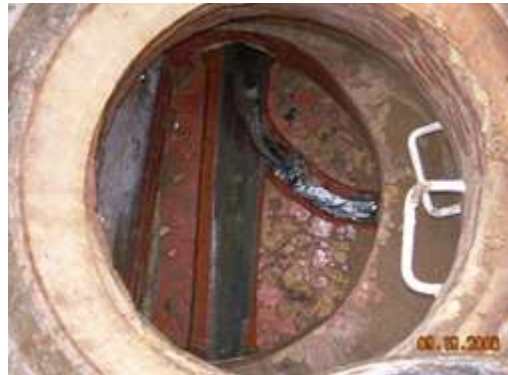
Top View

Evidence of surcharge - Bench debris.
Channel debris.

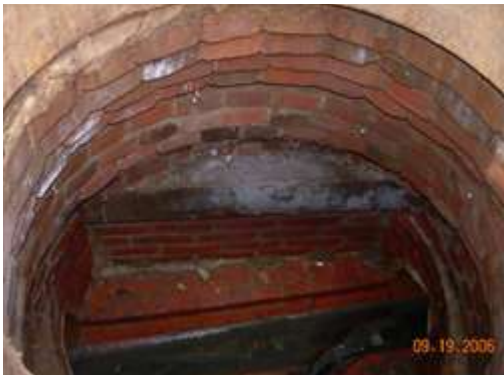
Defect

Frame leaks. Adjustment deterioration
and infiltration. Corbel infiltration.

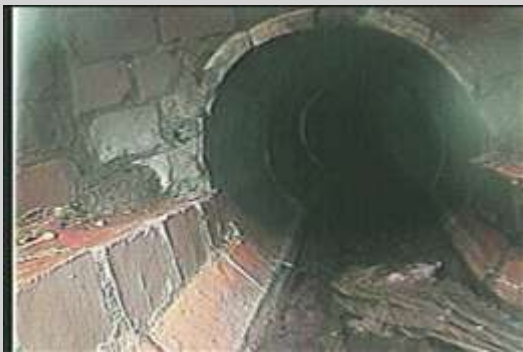
12 in. Circular Gravity Sewer Pipe Out @ 12 O'Clock

Deposits: ☐ None ☒ **Mud** ☐ Sludge ☒ **Debris** ☐ Grease

Silt Depth: **0.5** (in.) Deposits Extent: **Light**

Infiltration: **Evidence** Pipe Seal Cond: **Cracked**

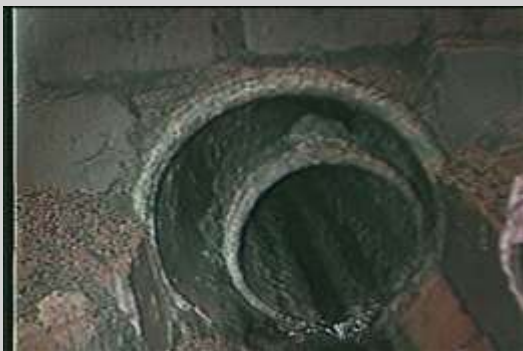
6 in. Circular Gravity Sewer Pipe In @ 3 O'Clock

Deposits: ☐ None ☐ Mud ☒ **Sludge** ☐ Debris ☒ **Grease**

Infiltration: **Evidence** Pipe Seal Cond: **Unknown**

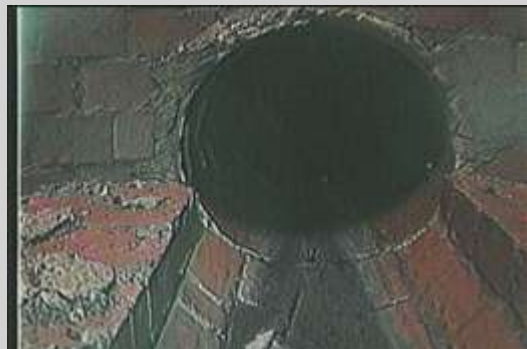
Pipe In @ 6 O'Clock

Infiltration: **Evidence**

Pipe Seal Cond: **Cracked**
